Fw 190D

Walk Around Number 10
squadron/signal publications

By E. Brown Ryle and Malcolm Laing

Focke-Wulf Fw 190D-9

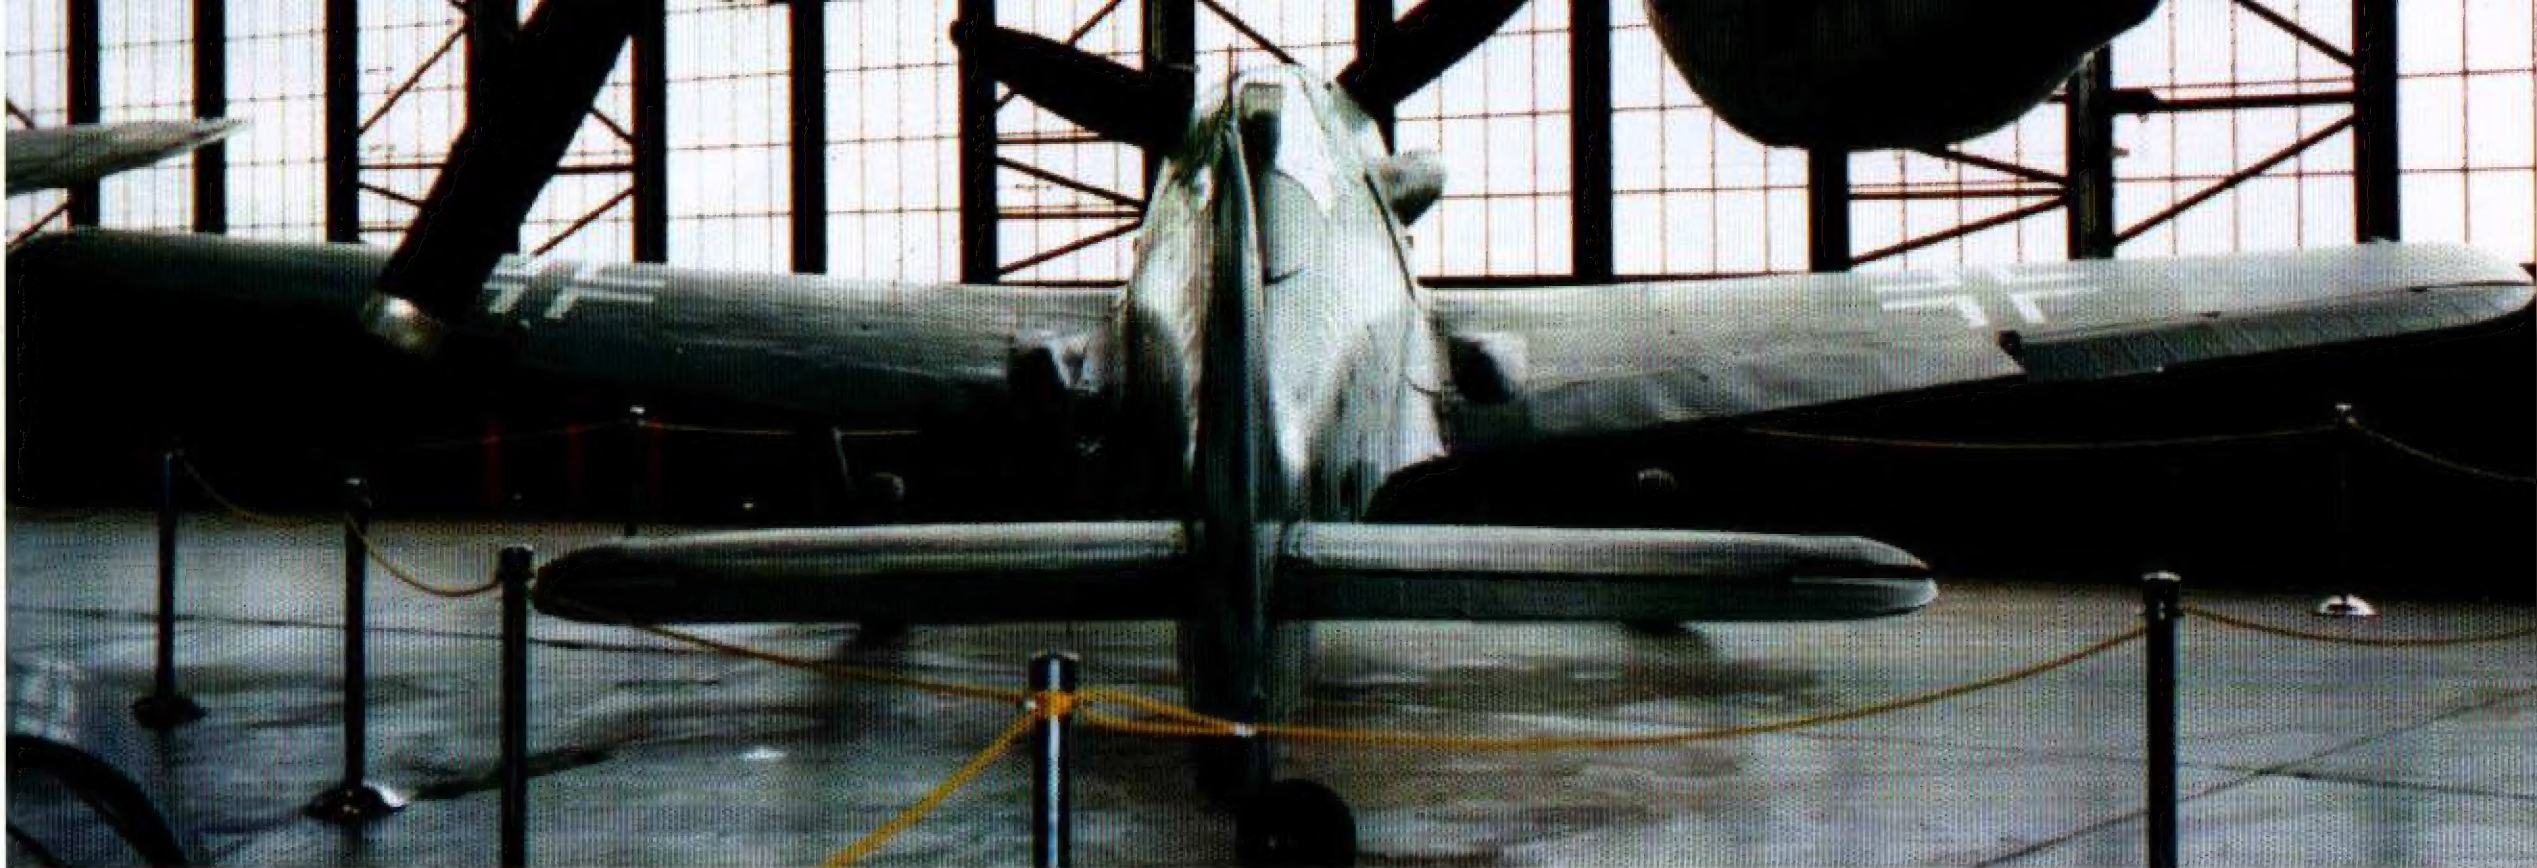
The Fw 190D-9 from the rear, the preferred view of Allied pilots. The taper from the thick forward fuselage to the thin tail assembly is evident. The tail wheel is turned 90 degrees to the right. (L & J Wahsum)

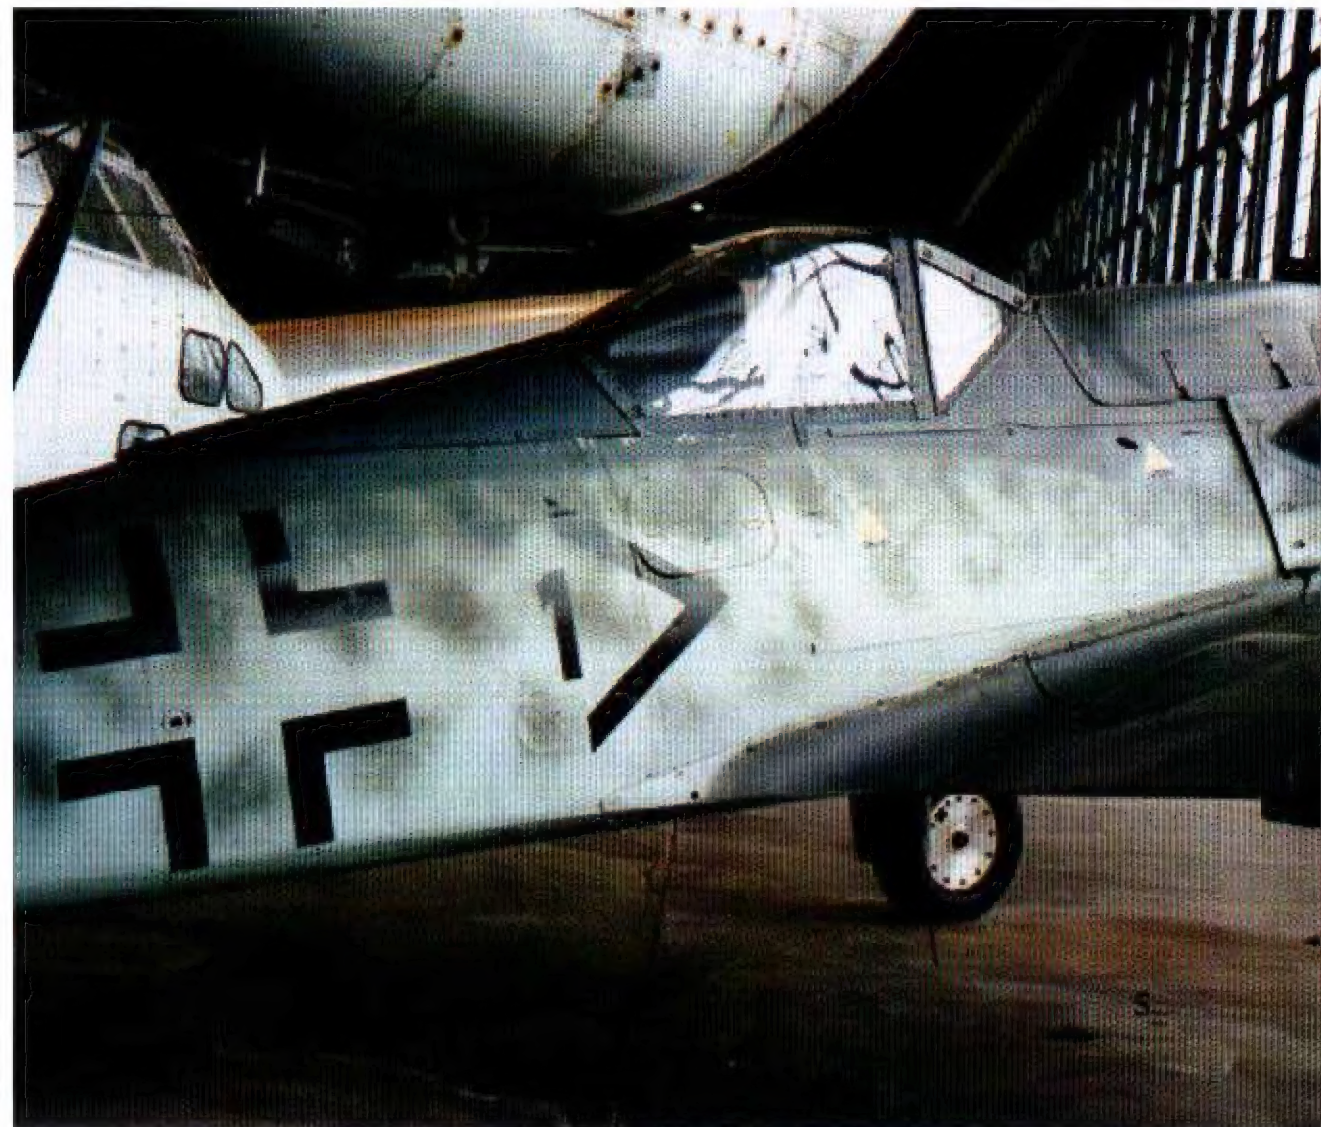
The starboard side of the fuselage showing the replica canopy (with the exterior hasp). The canopy's fit is not as close as it could be; further, the replica canopy has no rollers, so it will not slide. (L & J Wahsum)

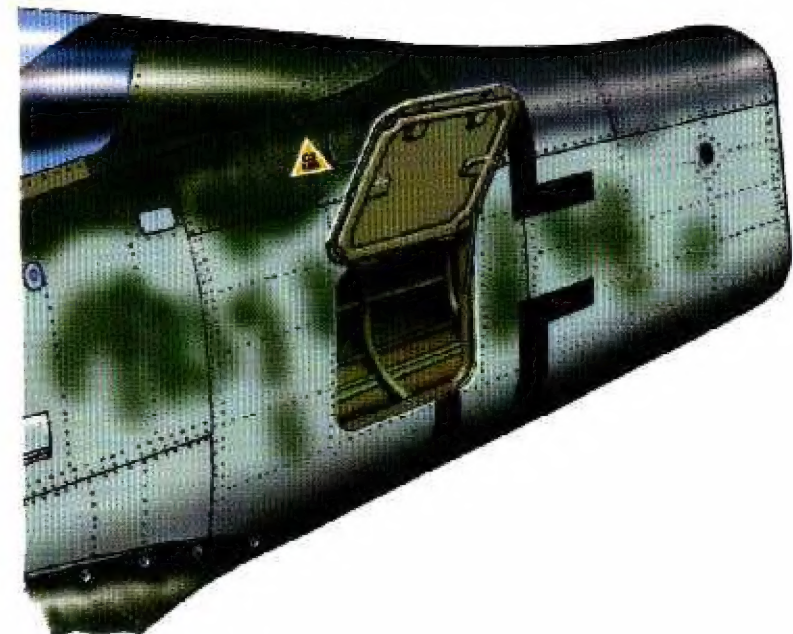
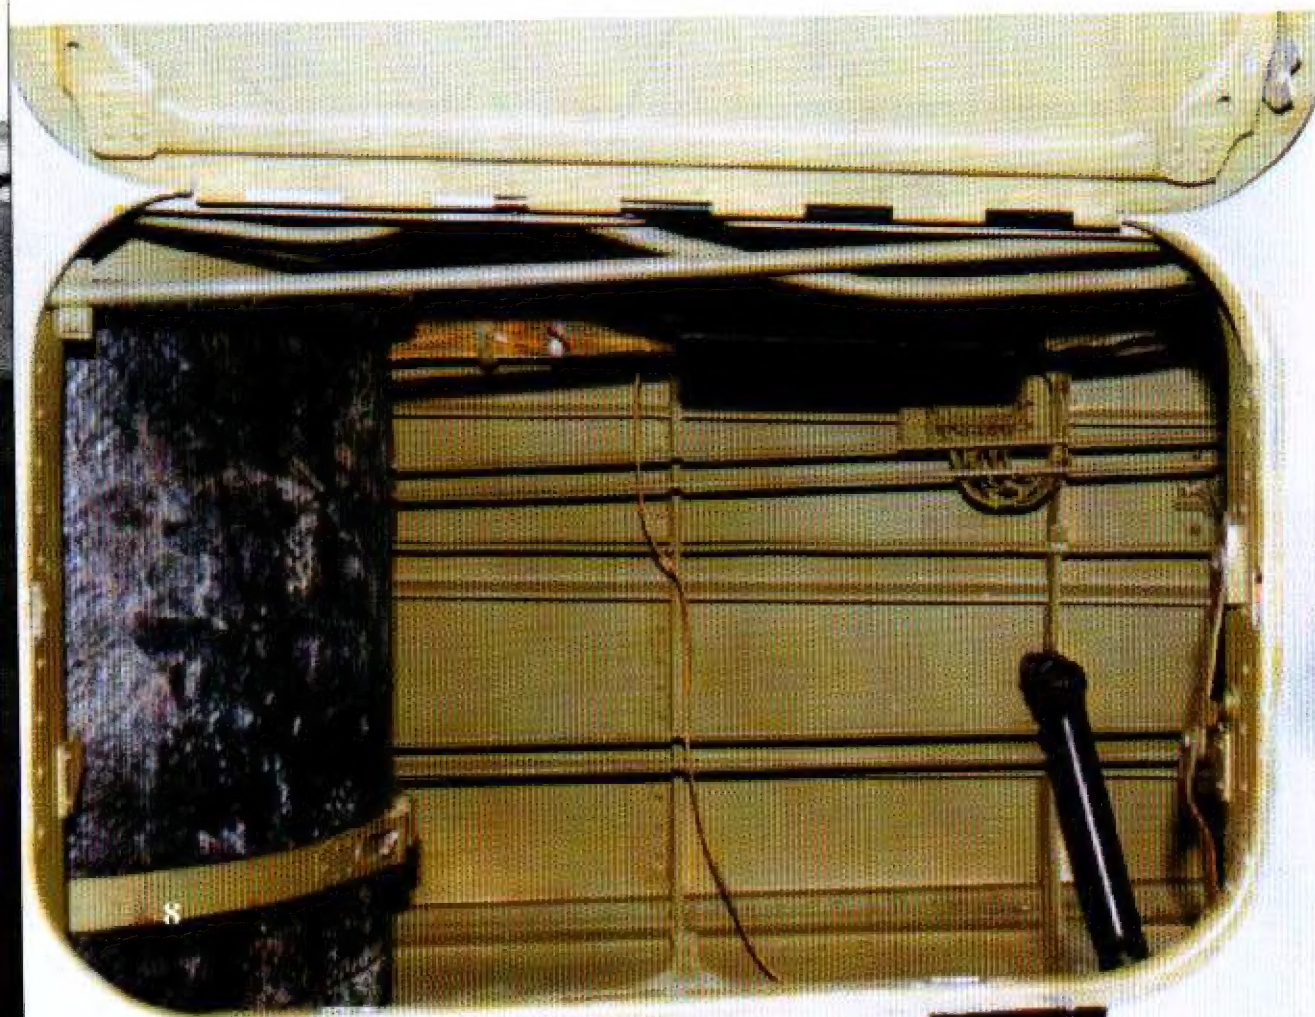
Fuselage Access Door

On the port side of fuselage is the aft fuselage access door. This door is original and has the correct four latches. (Author: Ryle)

Looking straight into the fuselage access opening, the auxiliary fuel tank (left) and the starter crank (right) readily stand out. On the opposite side of the fuselage the elevator control cables run along the side of the fuselage. (Author: Ryle)

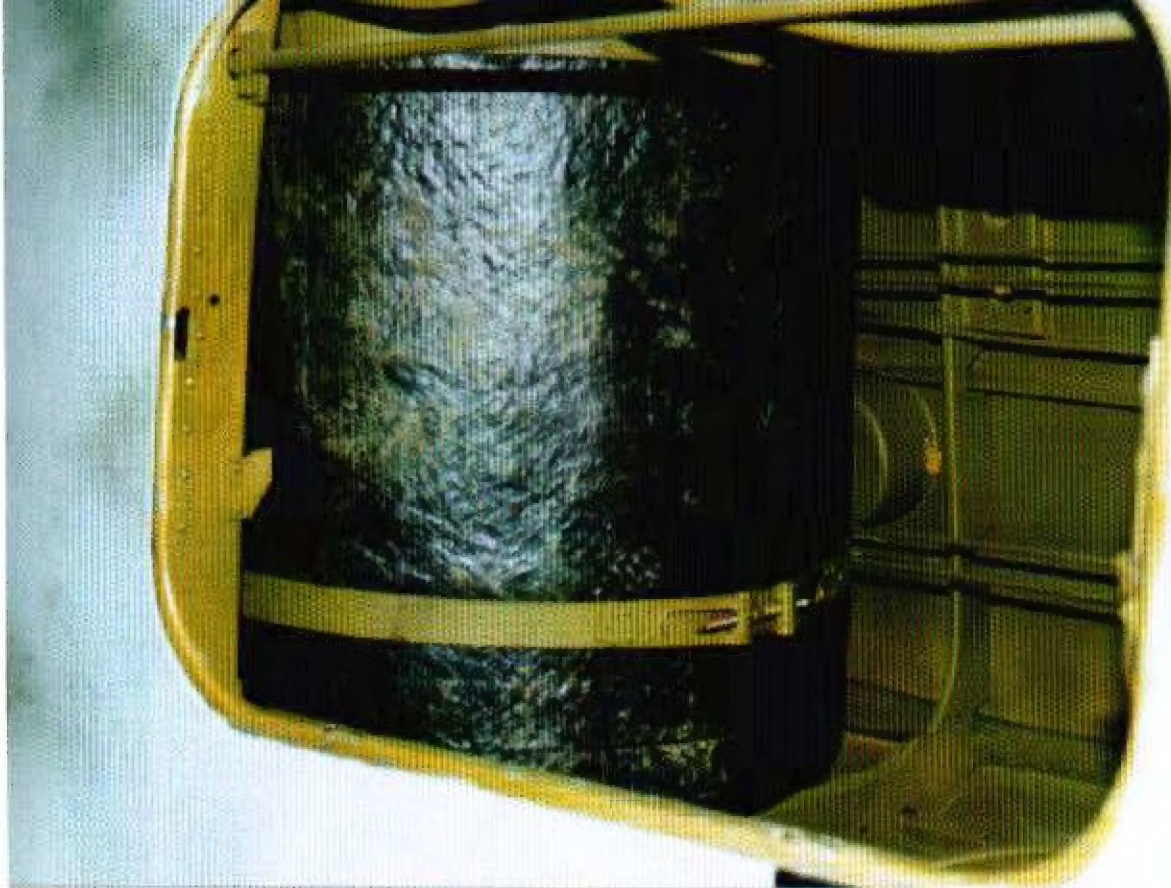
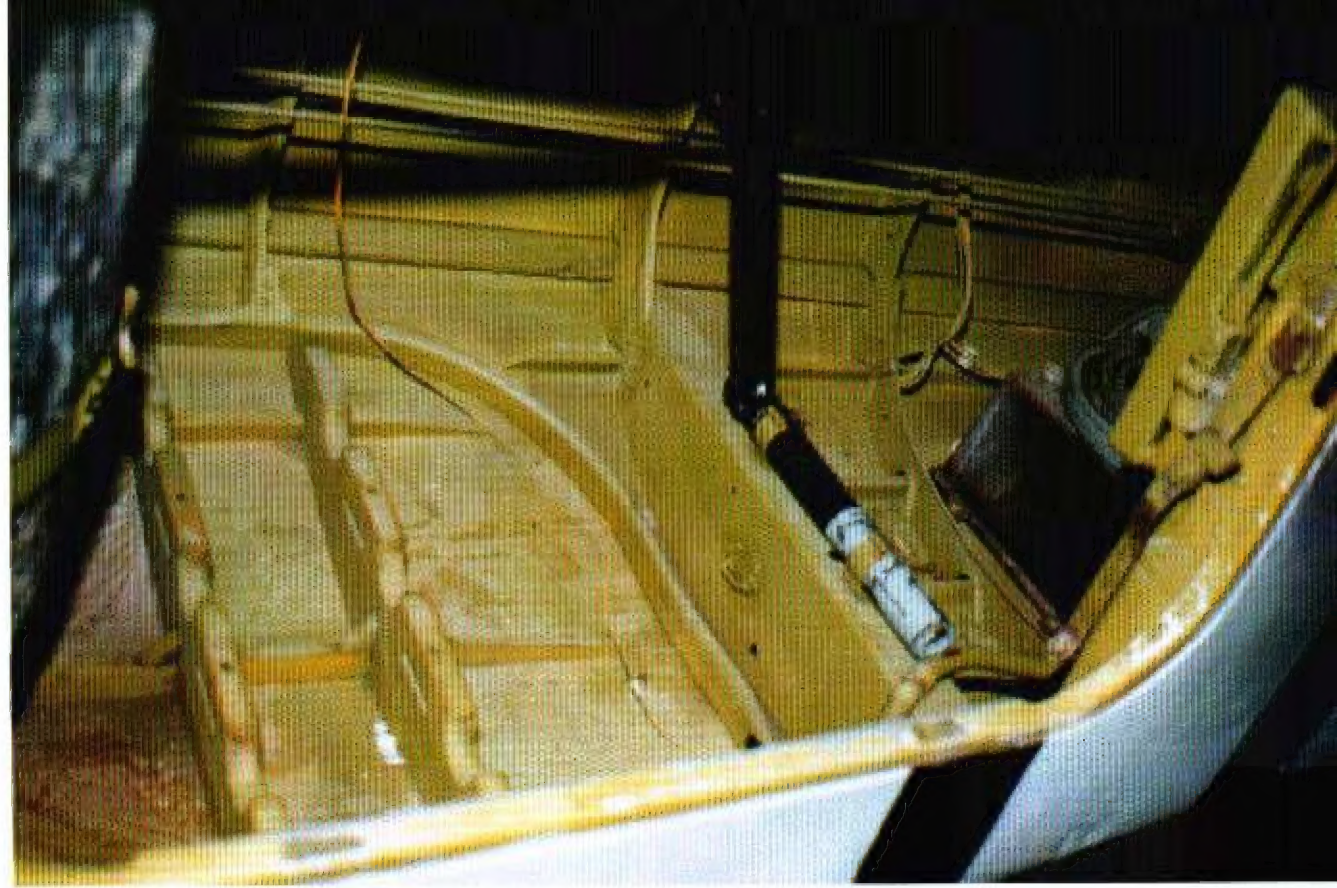
(Above) Looking forward through the aft fuselage access door at the fuselage auxiliary 115 liter (25.3 gal) fuel tank located directly behind the cockpit. This tank did not have a cockpit indicator, and the pilot considered it empty when the rear tank of the two main fuel tanks, both located below the cockpit, indicated below 240 liters. (Author: Ryle)

(Above right) On the floor of the fuselage is the somewhat rounded door that also provided access to the auxiliary fuel tank. To save on strategic materials late in the war this was made of wood. The engine starter crank is clipped to the lower bulkhead just in front of the remote compass. (Author: Ryle)

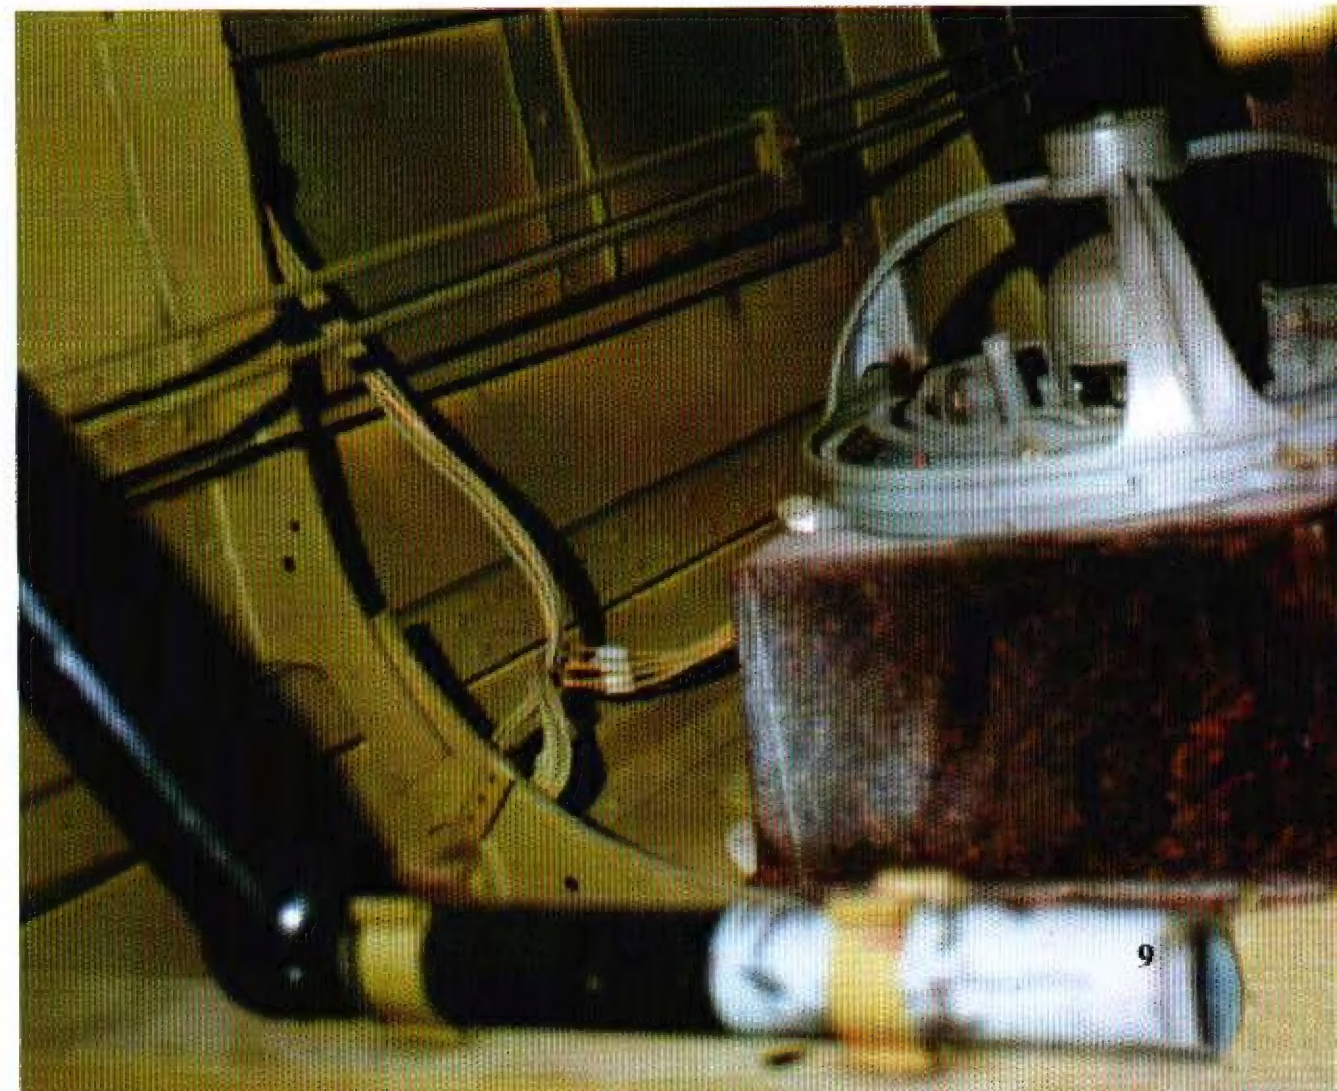
(Right) Inside the fuselage looking aft at the remote compass. Along the interior are vertical stiffeners that provided strength to the fuselage skinning. (Author: Ryle)

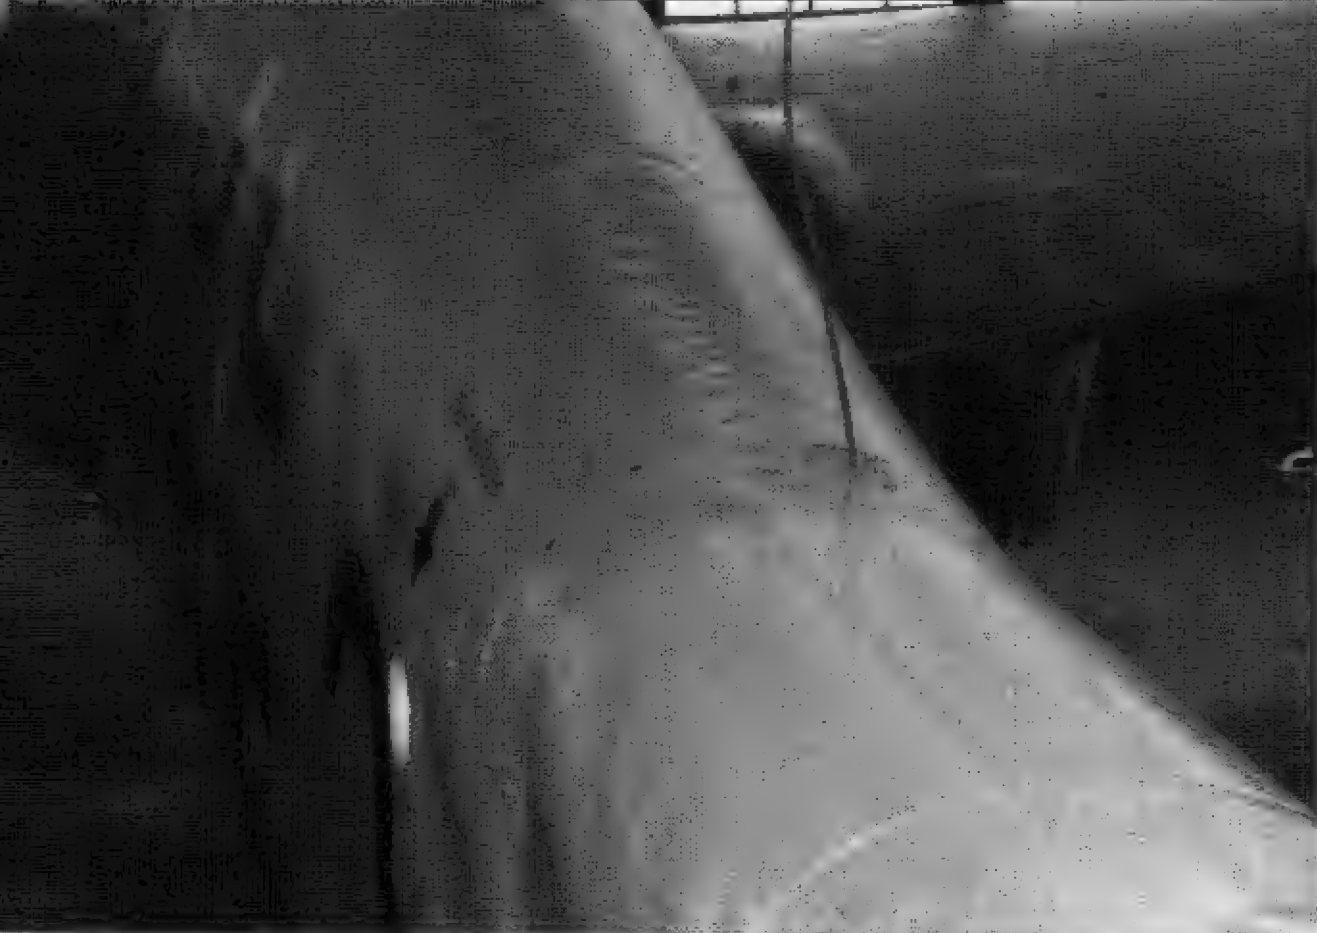
(Above) The vertical antenna wire's attachment point. There is no retraction unit to maintain tension on the antenna wire so it collapses unless the canopy is in the fully closed position. (Author: Ryle)

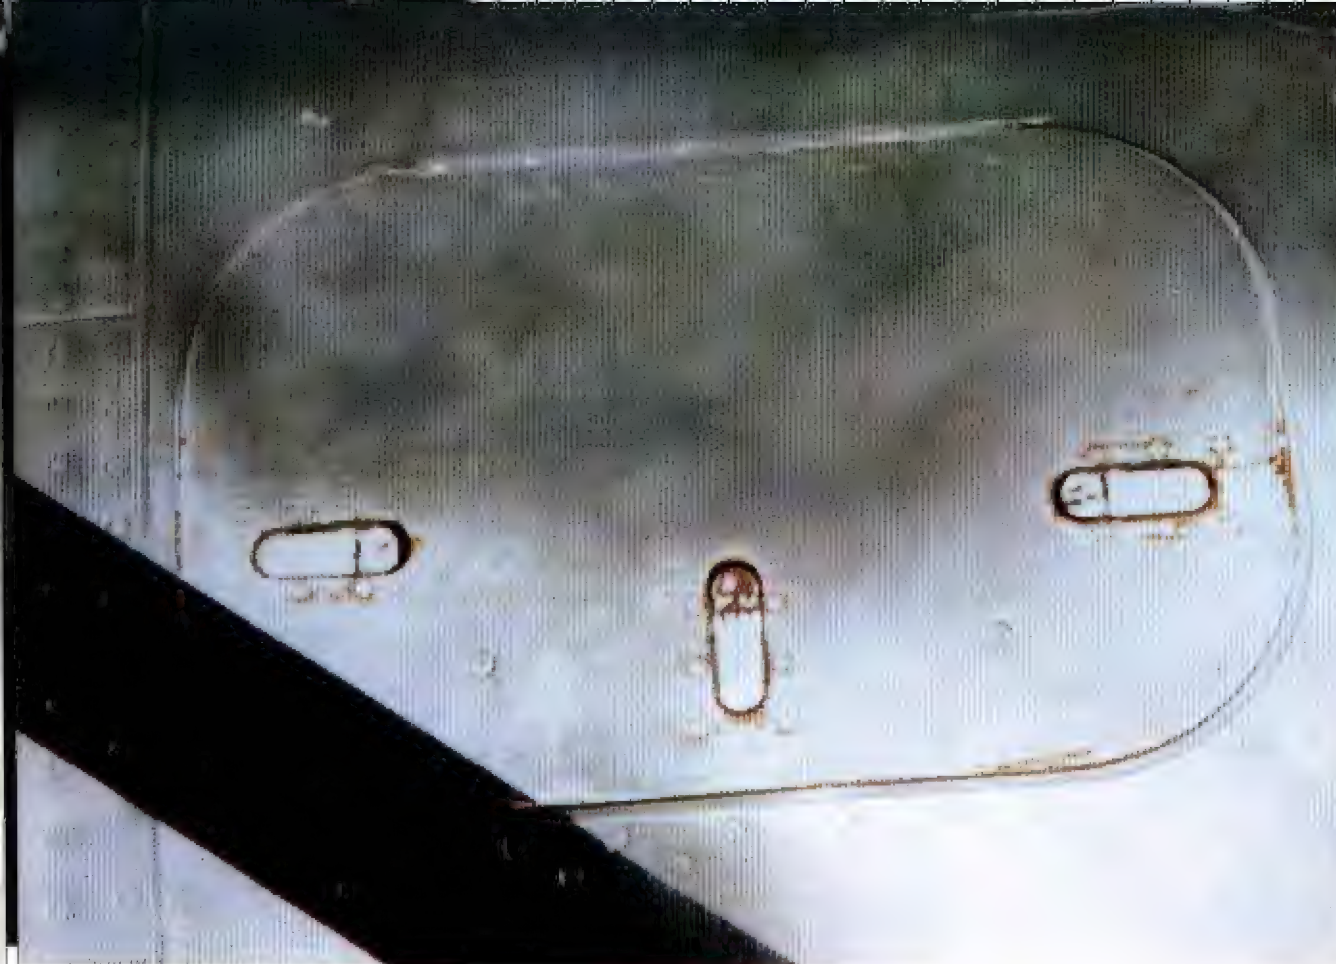
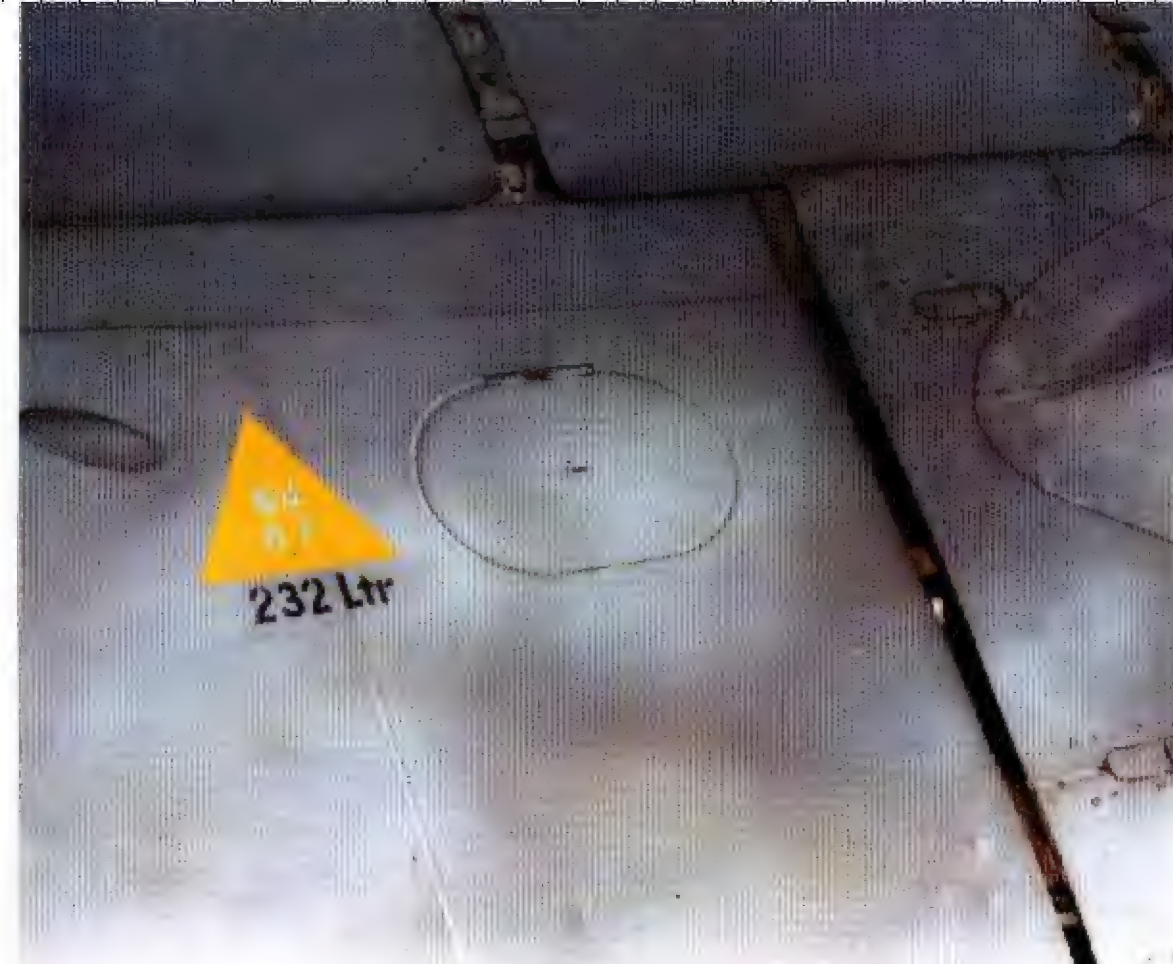
(Right) The plug used to extend the fuselage on all Fw 190D aircraft were not as well fitted as it is on this aircraft. And even as well fitted as it is here, it is not flush at all points. On the lower left of the fuselage aft of the plug a repair patch may be seen. (J. Bishop)

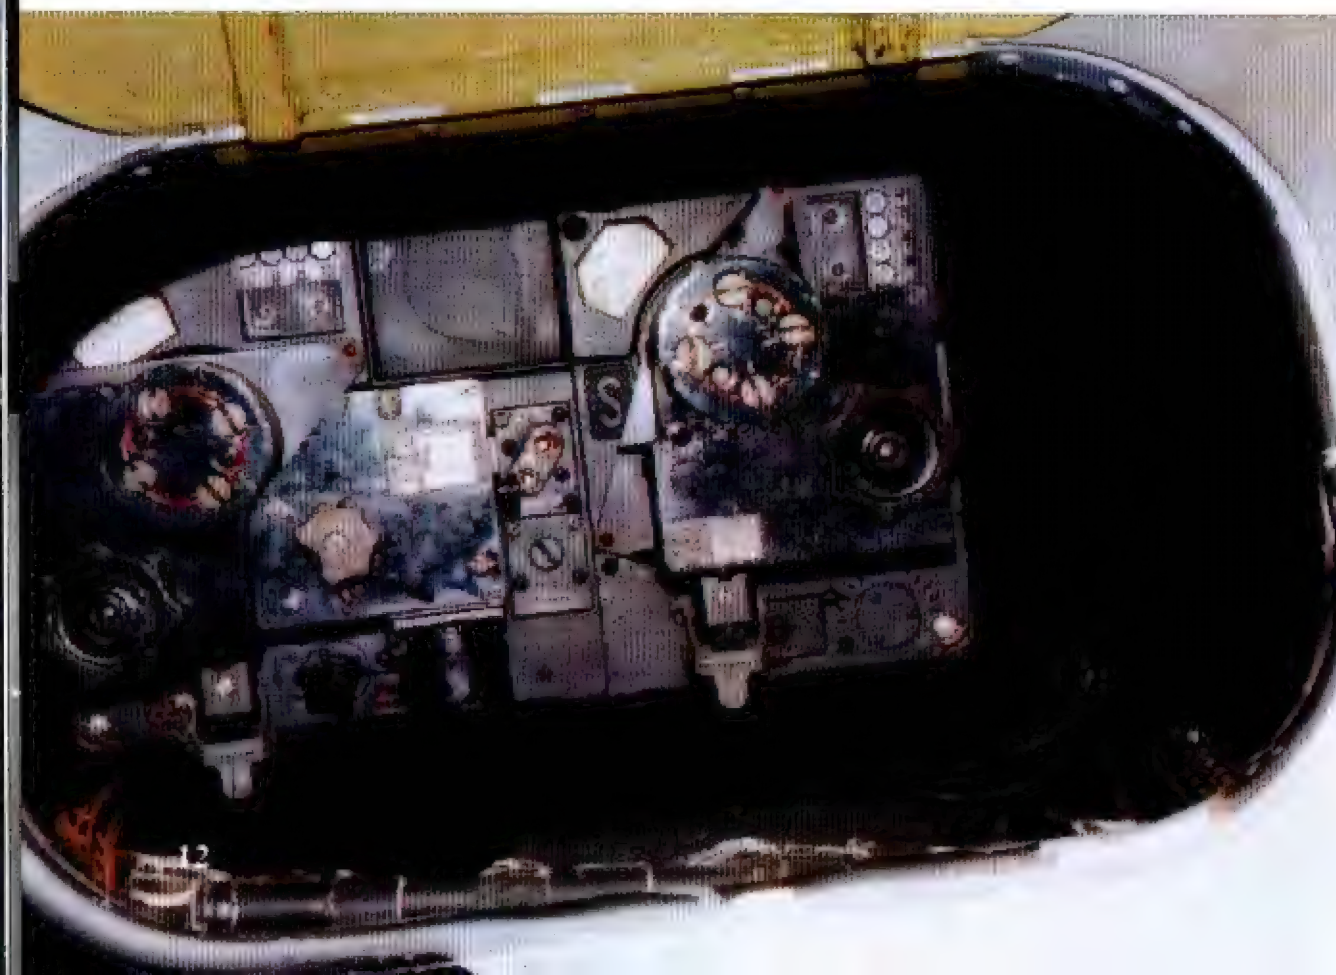
(Above left) The radio access door on the starboard side of the aircraft just behind the rear fuel filler hatch. The three latches are in the closed position. (J. Bishop)

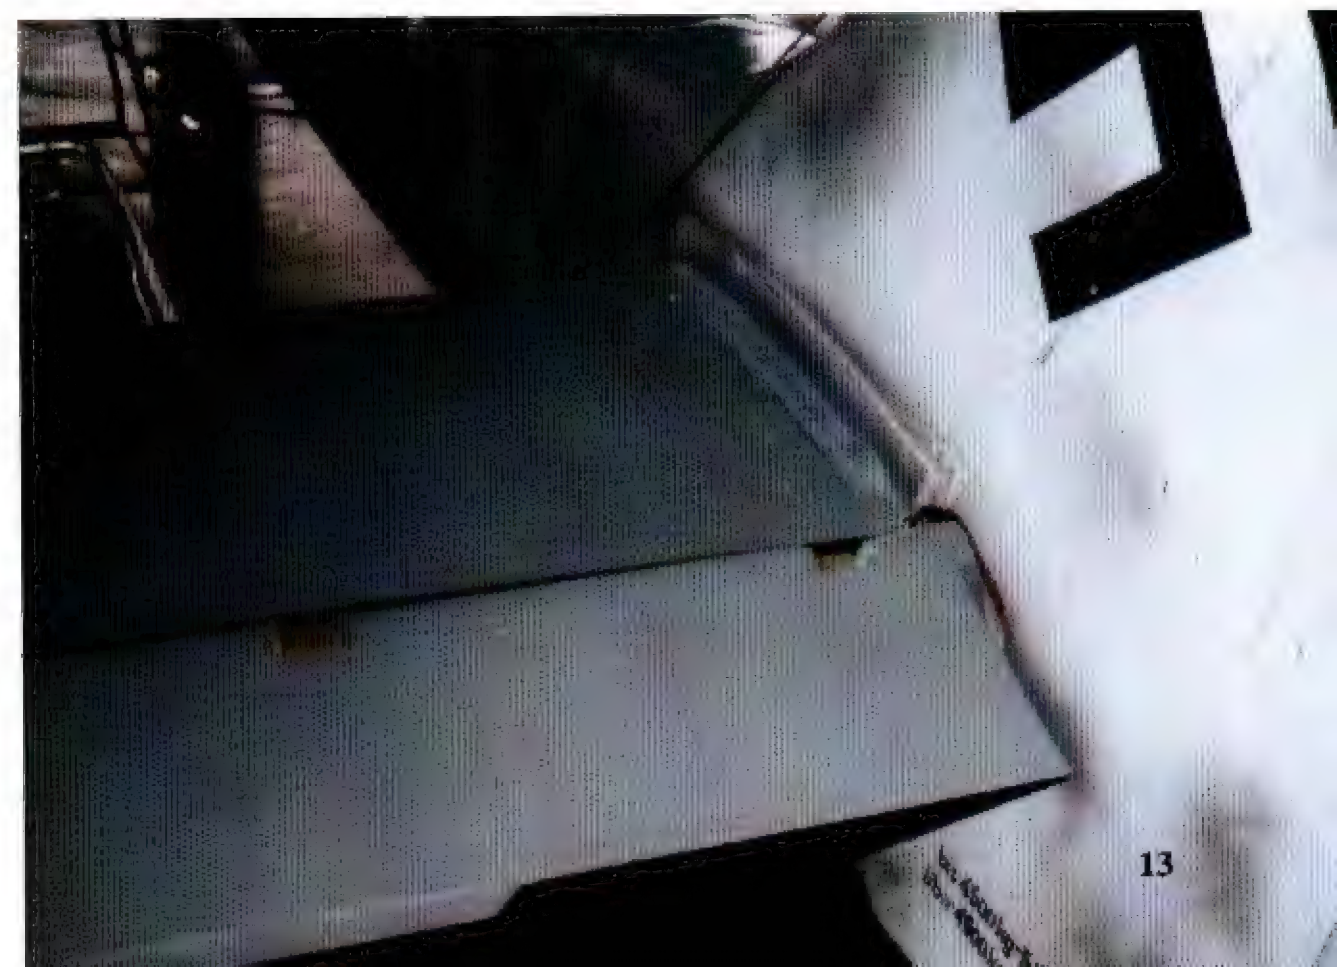
(Right) The port side of tail assembly showing the horizontal stabilizer attachment. The small stiffener just above the rear edge of the stabilizer fairing is found on most late war Fw 190s (J. Bishop)

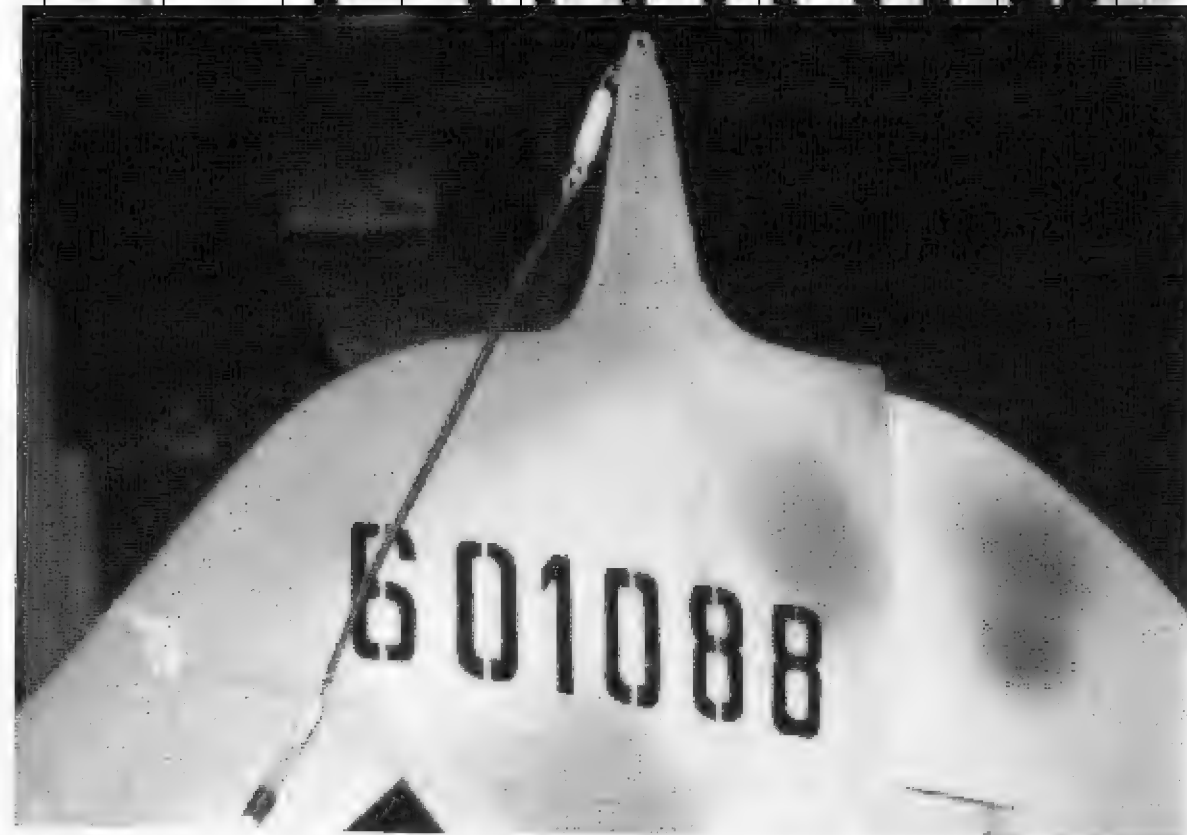
The canopy is open so the antenna wire drapes down slack. The aircraft's work number (601088) indicates it was built in a production batch of eighty aircraft that were some of the last Fw 190s to be produced before the end of the war. (Author: Ryle)

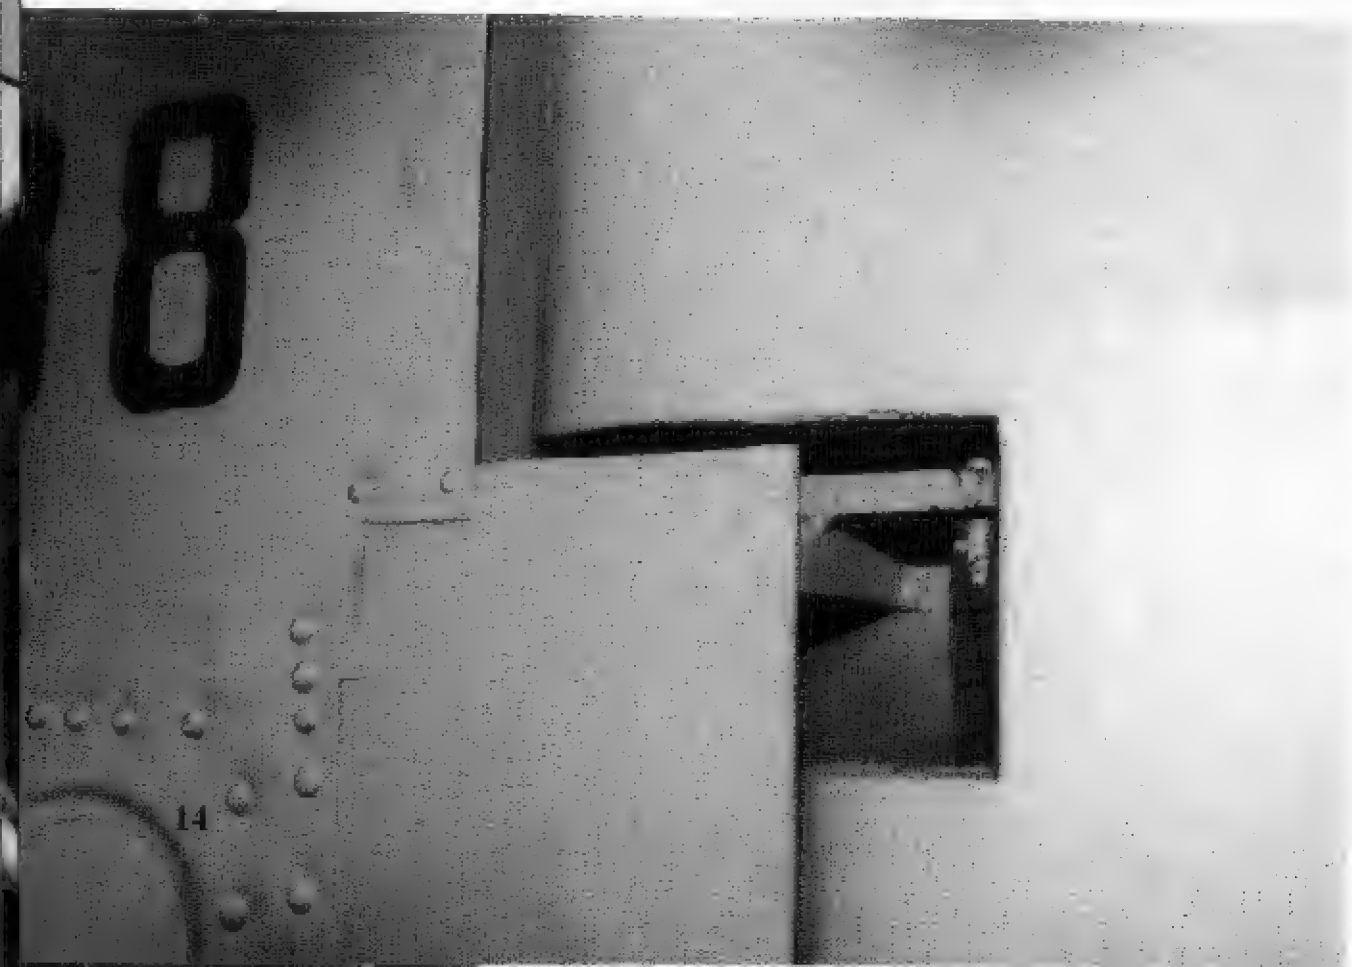
With the canopy in the closed position the antenna wire is pulled taught. The small spring is to maintain tension. (Author: Ryle)

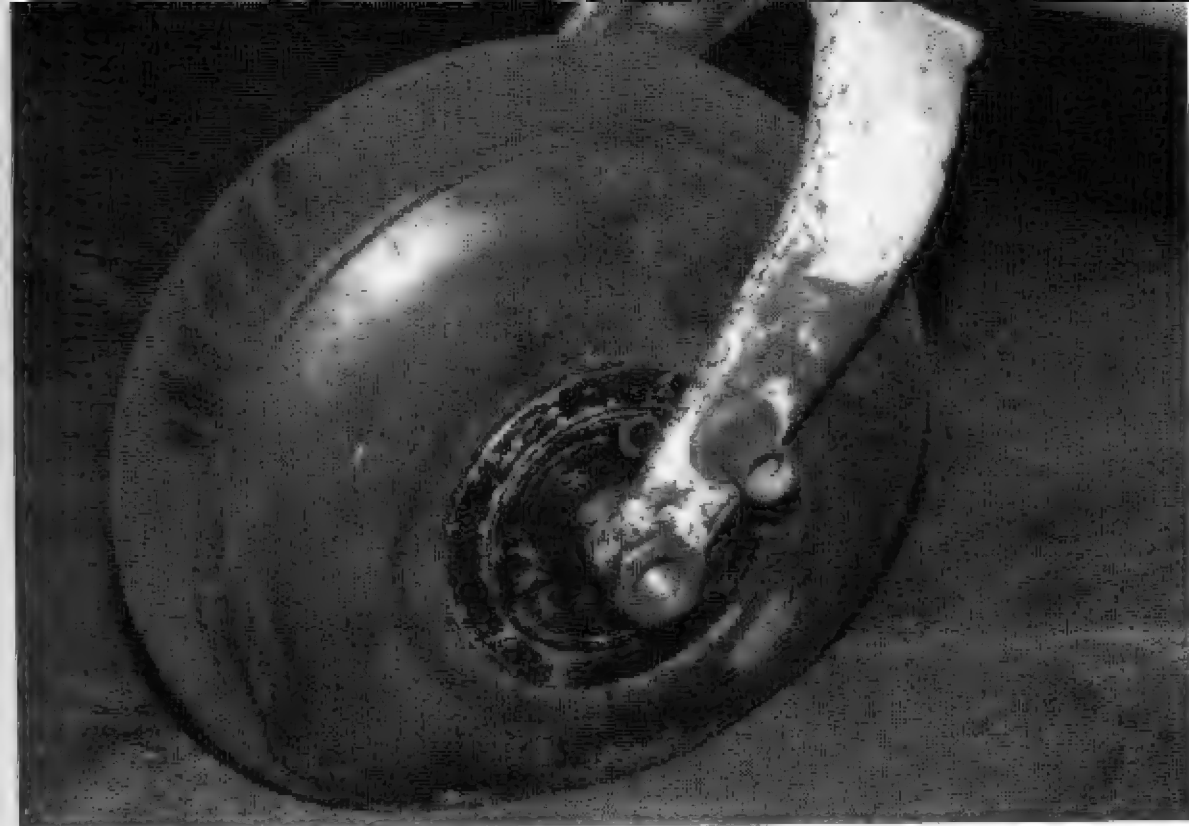
The tail wheel fork is a late war welded type with prominent rough weld lines. As the war got more desperate such things as deburring weld joints were ignored especially when they did not affect the functioning of the equipment. With no original available an American tail wheel and tire have been substituted. An unusual feature is the addition of a fairing around the tail wheel opening. (Author: Ryle)

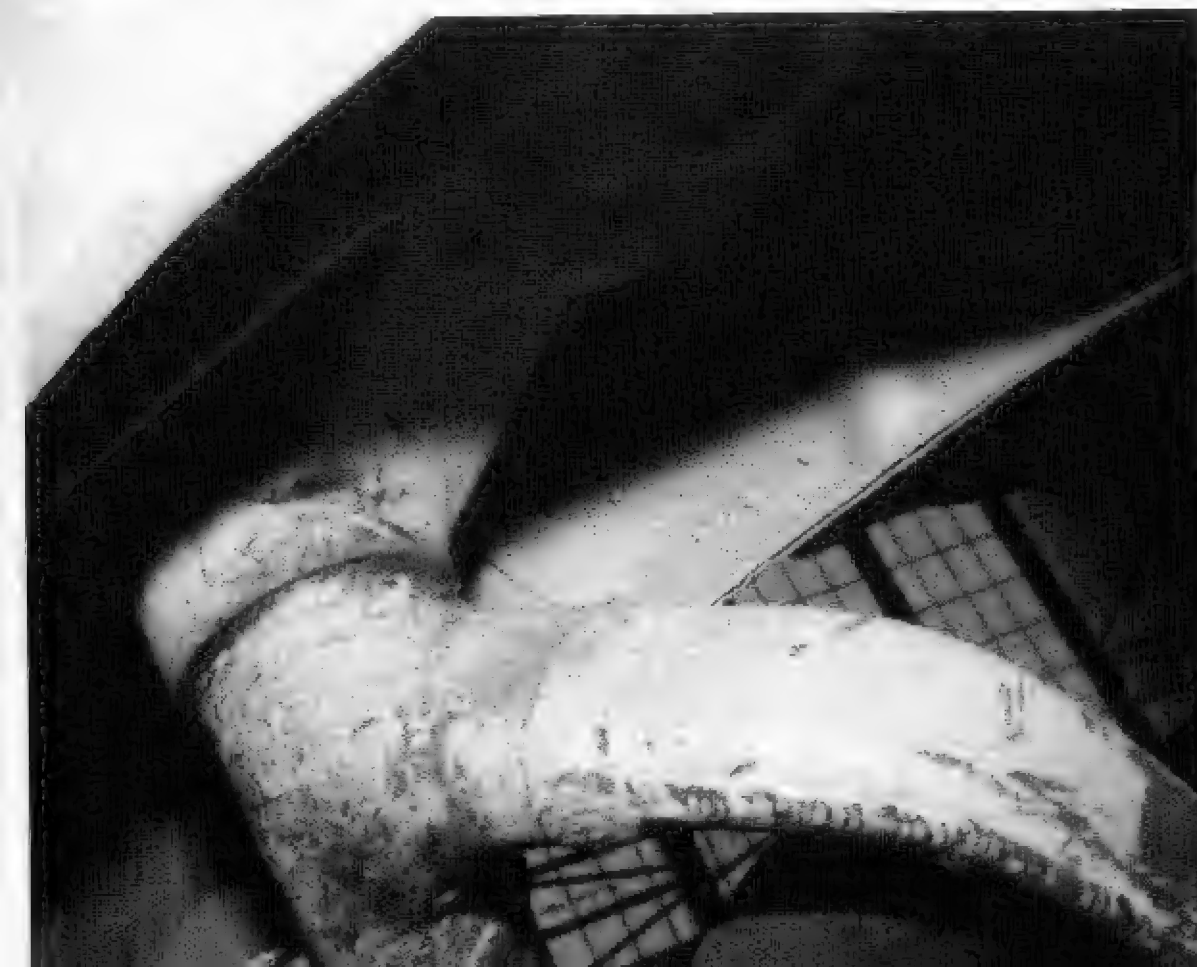
The replica canopy fits poorly to the armored windscreen. The small tube on the front of the windscreen is the windscreen (cleaning) spray tube which cleaned the windscreen with fuel from the fuel line running to the fuel pressure gauge in the cockpit. It has broken and slipped down, but its lower attachment can clearly be seen. (L & J Wahsum)

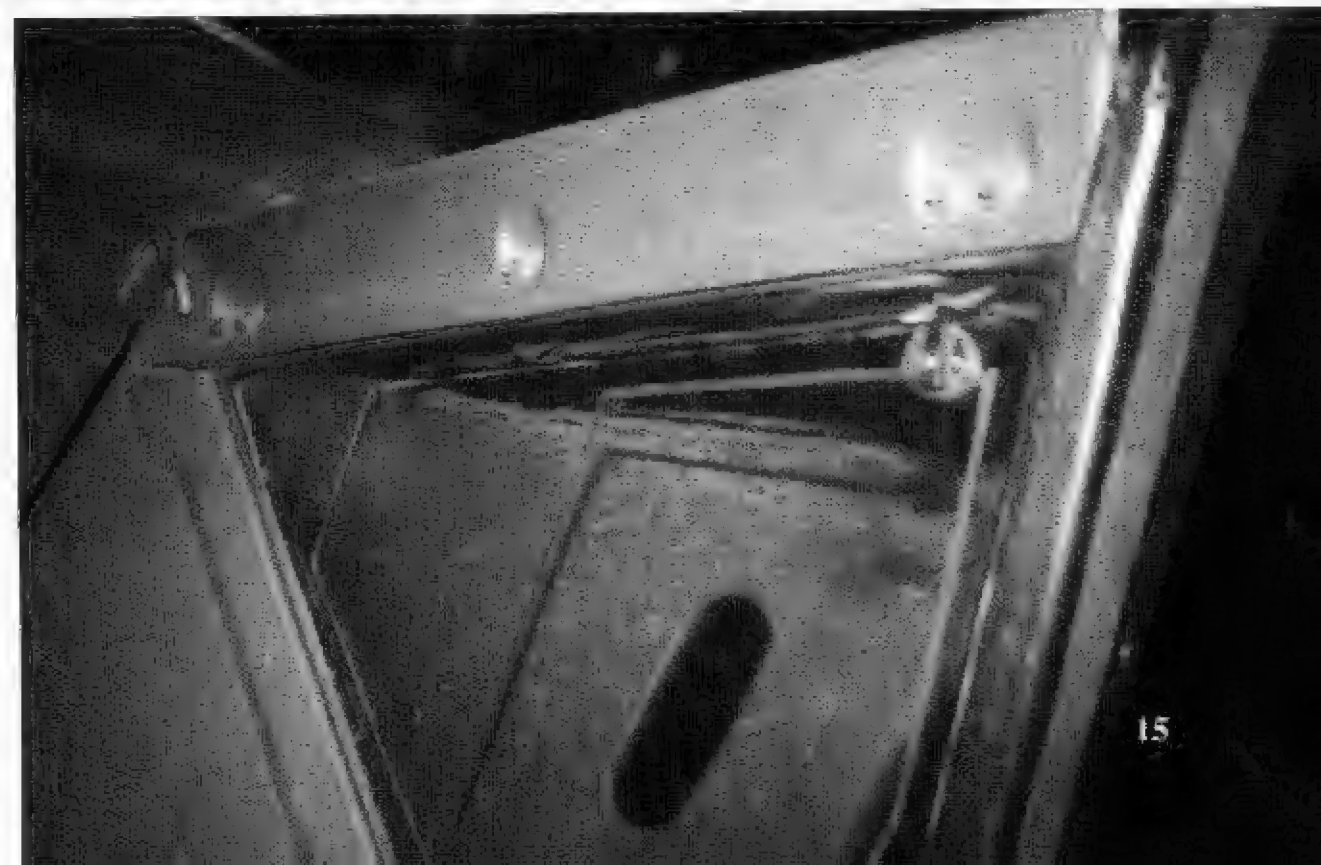
Embedded in the heavy glass of the armored windscreen are the small red strips of the electric anti-ice system essential to high altitude operations. The fittings (bolts) along the top edge of the windscreen are double, single, double. Other windscreen bolts have been documented as double, double and double. (Author: Ryle)
